USAARL Report No. 2004-07

Issues in Design and Safety of Helmet-Mounted Displays – Results of a Rotary-Wing Pilot Survey

U.S. Army
Aeromedical Research
Laboratory

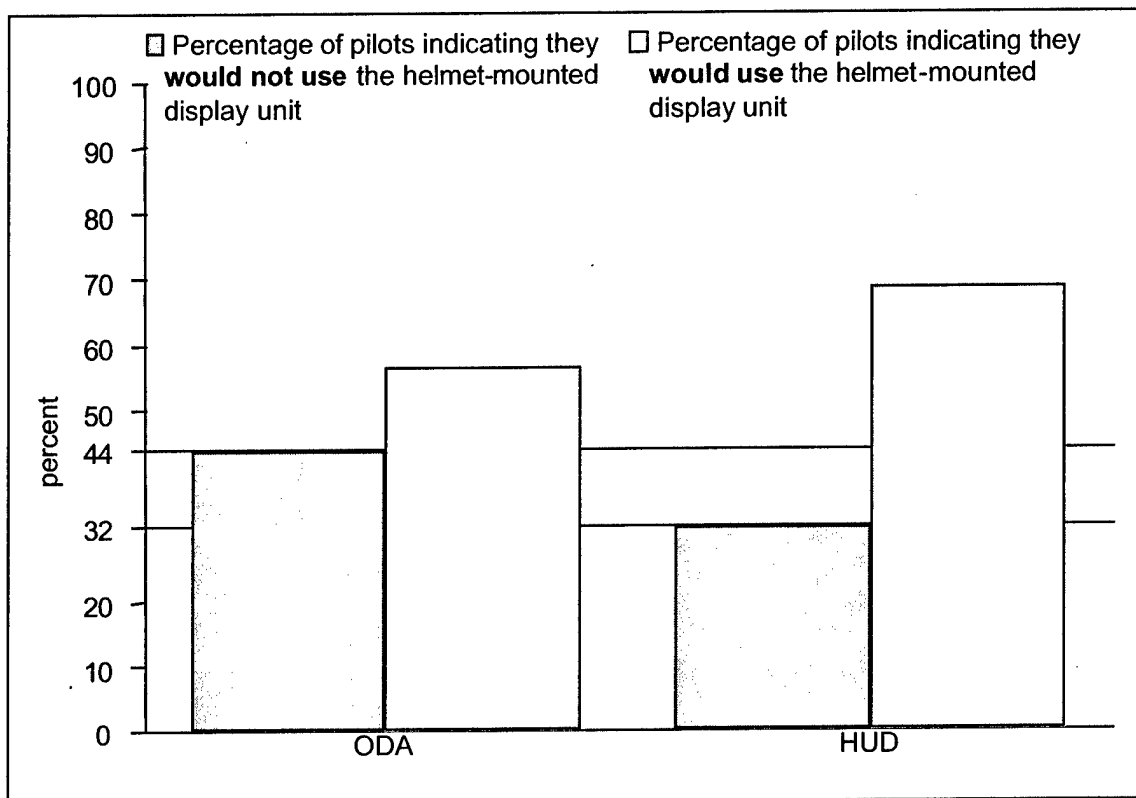
Figure 1. Percent indicating they would use the HUD/ODA.

Although the majority of respondents (257 or 63 percent) indicated that they would use their display if given the option, 76 or 32 percent of HUD users and 71 or 44 percent of ODA users indicated they would not use their display device if they were given the option (Figure 1). The following text outlines their reasons for this and their suggested modifications.

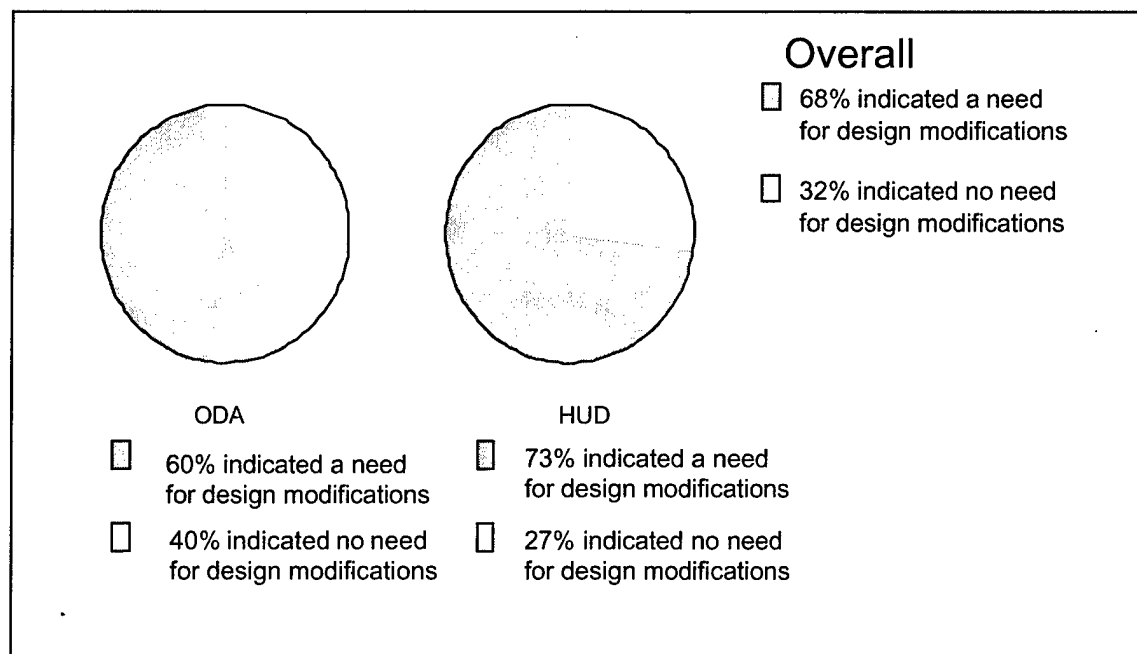
Figure 2. Percent requesting design modifications.

A total of 272 (68 percent) of survey participants indicated that design modifications should be made to their display devices (Figure 2). The majority, 175 (64 percent) of these were HUD users, while 97 (36 percent) of those desiring design modifications were ODA users.

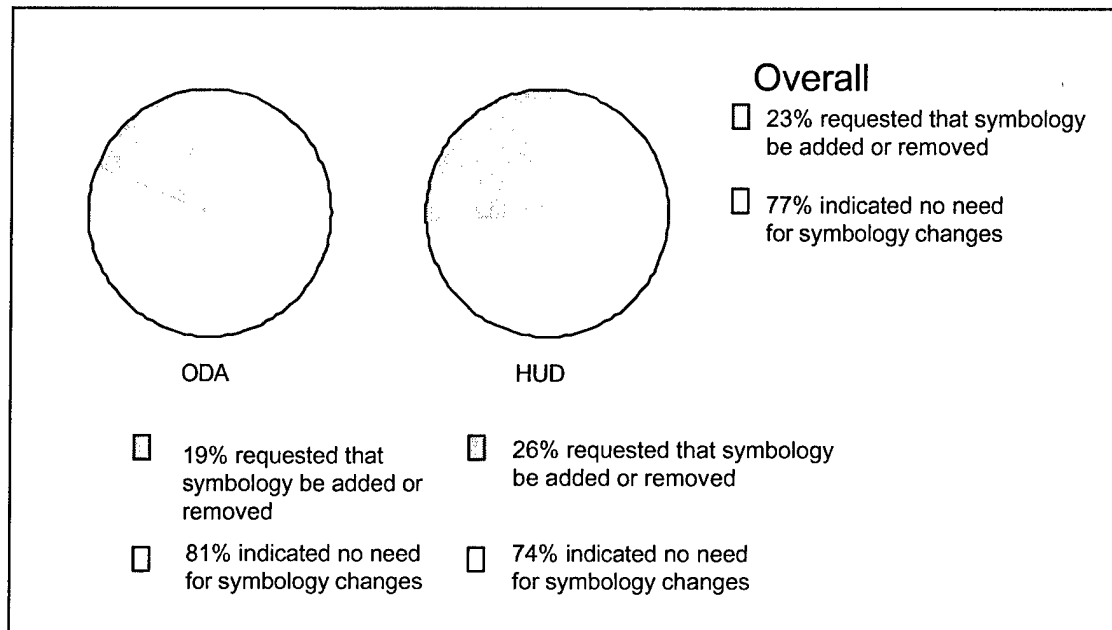
Figure 3. Percent requesting that symbology be added or removed.

Although the majority of aviators surveyed indicated no need for any symbology to be added or removed from their device, a total of 94 (23 percent) pilots surveyed indicated the need for changes in the symbology of their device (Figure 3). Of these pilots, the majority, 63 (67 percent), were HUD users.

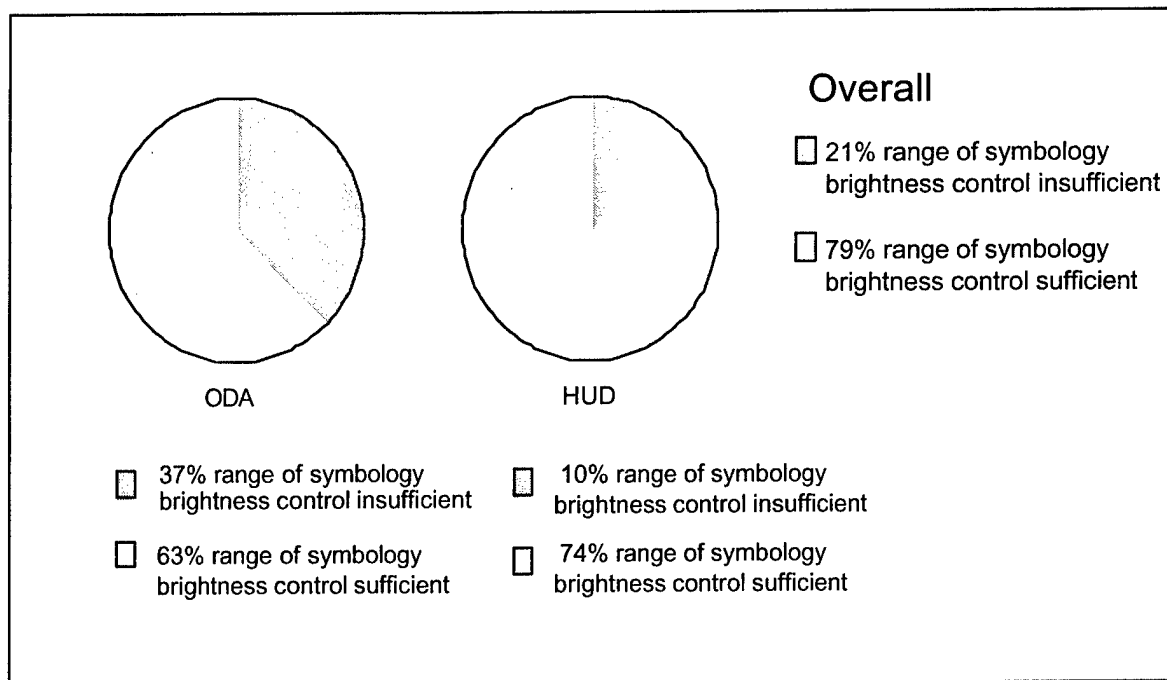
Figure 4. Percent indicating range of symbology brightness control insufficient.

A number of survey participants (86 or 21 percent) indicated that the range of symbology brightness control was not sufficient with their display device (Figure 4). A total of 25, or 10 percent of HUD users within this survey, indicated the range of brightness control was not sufficient. A total of 61 (37 percent) of ODA users also indicated their range of brightness control was not sufficient. The majority of pilots (264 or 65 percent of survey respondents) also indicated that they frequently had to adjust the brightness of their symbology. A total of 170 (64 percent) of these pilots were HUD users, while 94 (36 percent) were ODA users.

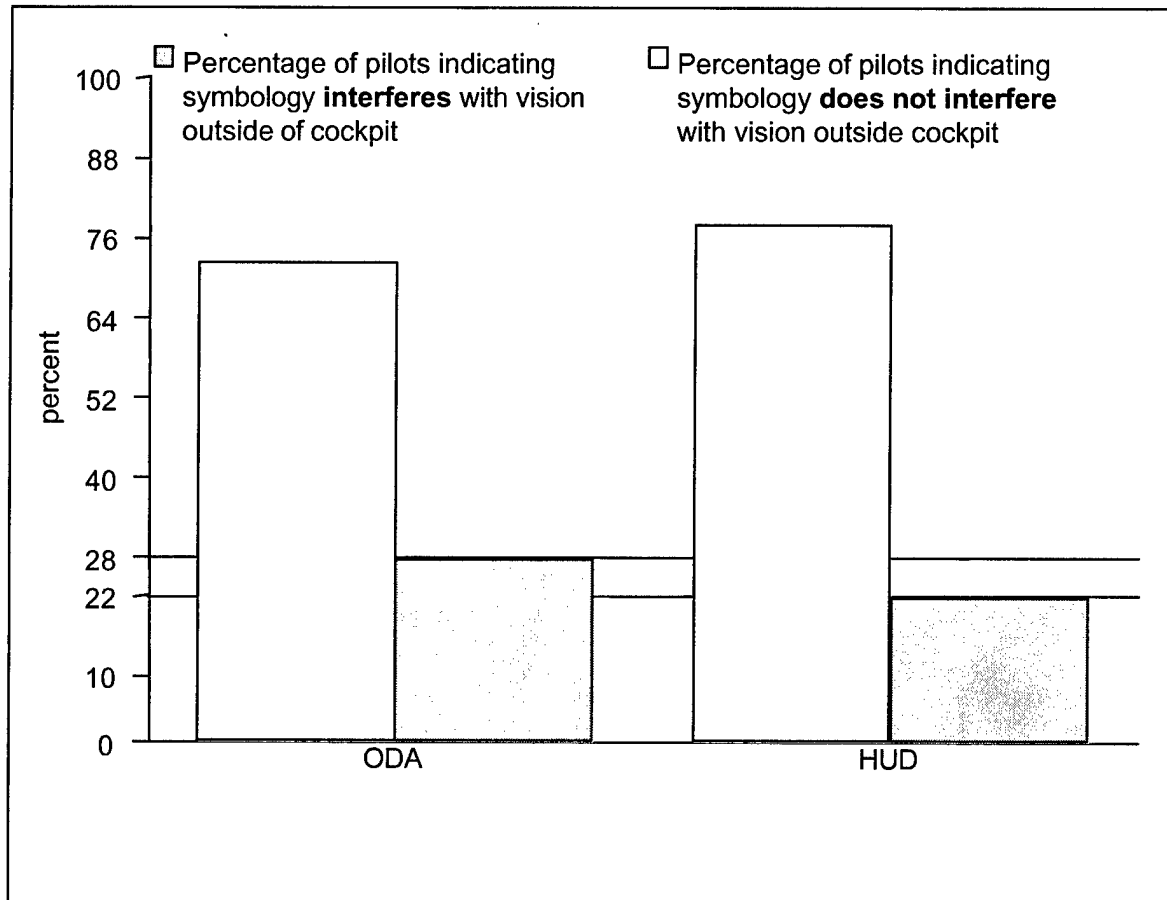
Figure 5. Percent indicating symbology interferes with vision outside the cockpit.

A total of 98 (24 percent) pilots surveyed responded that at some time the symbology of their display device interfered with their vision outside of the cockpit. A total of 53 (54 percent) of these responders were HUD users. Although the majority of both HUD and ODA users indicated that the symbology did not interfere with their vision outside the cockpit, 45 (28 percent) ODA users and 53 (22 percent) HUD users indicated that it had interfered with their vision at some time (Figure 5). Pilots also often wrote that the brightness of the display was often too bright for night operations. Written questionnaire responses suggested potential compromises in safety in the time necessary to adjust their vision from the bright display to visualize their position outside the cockpit.
